**EMRP SIB05 NewKILO WP4  
Deliverable 4.2.4**

**Report on application of the cleaning procedures to mass standards including gravimetric results**

**Goran Grgić (MGRT – MIRS), Matej Grum (MGRT – MIRS), Kilian Marti (METAS), James Berry (NPL)**

**May 2015**

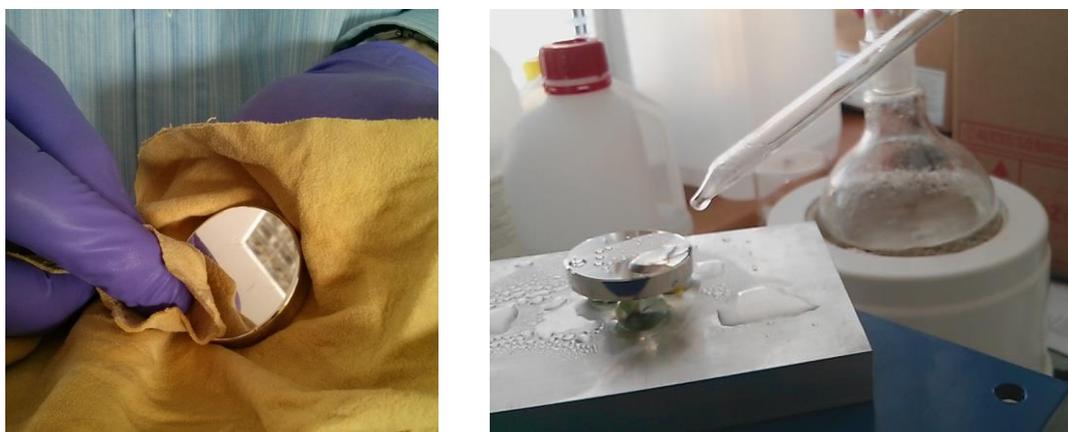
Figure 1: Cleaning with chamois leather cloth soaked in ether-ethanol mixture (left) and washing with bidistilled water steam jet (right).

The BIPM nettoyage-lavage cleaning procedure was carried out according to [3]. The first cleaning stage of the process, which is shown on Figure 1 (left), consisted of rubbing the standard with a natural chamois leather cloth soaked in the mixture of equal parts of diethyl ether (Sigma-Aldrich, purity  $\geq 99,8\%$ ) and ethanol (Sigma-Aldrich, purity  $\geq 99,8\%$ ). The second stage of the process, shown on Figure 1 (right), consisted of washing the standard with bidistilled water steam jet.

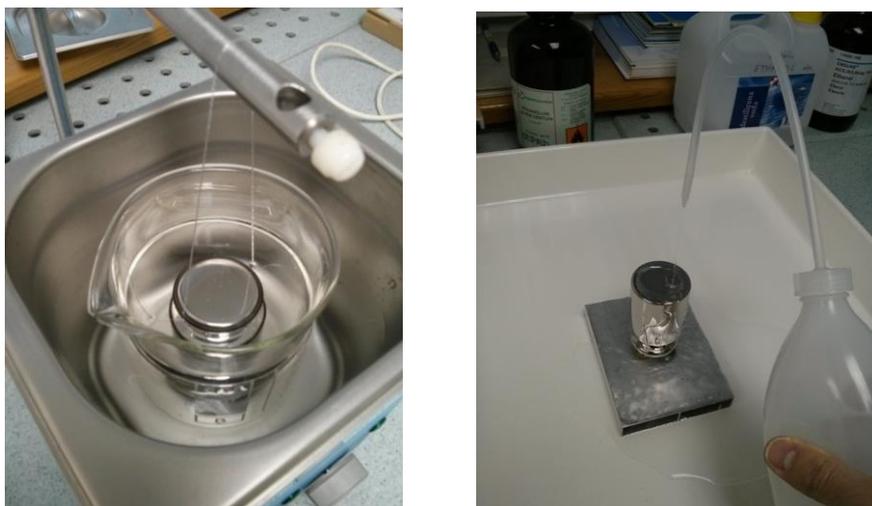
Figure 2: Cleaning in the ultrasonic bath (left) and rinsing with bidistilled water (right).

The first cleaning stage consisted of washing the standard in solvent in an ultrasonic bath. The ultrasonic bath used was 250 W Iskra PIO model 2 GT. The solvent used was ethanol (Sigma-Aldrich, purity  $\geq 99,8\%$ ). The platinum-iridium disc standards were placed horizontally inside an ethanol filled glass beaker which was then placed in the bath. The stainless steel standards were suspended into the beaker using a thin nylon filament as show on Figure 2 (left). The bath was operated for a period of 5 minutes. The second stage of cleaning process involved rinsing the standard with bidistilled water. Bidistilled water was poured over each surface of the standard in copious amounts for about 5 minutes as shown on Figure 2 (right). The remaining water droplets were wiped off with a lint free tissue. Then the weight was left to dry for at least 48 hours.

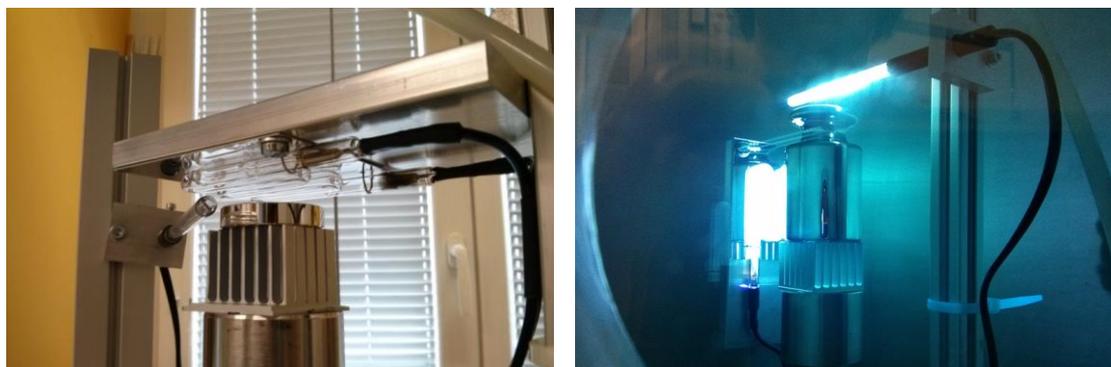
Figure 3: Platinum - iridium disc standard (left) and stainless steel standard (right) in the UV/ozone apparatus

The apparatus for UV/ozone cleaning (Figure 3) was designed and manufactured for MGRT based on the design introduced in [4]. The apparatus consisted of a 115 L cylindrical steel chamber equipped with a valve to control the gas flow of air. Compressed air was supplied from a gas cylinder into the chamber at the flowrate 1 L/min. A charcoal filter was included in the exhaust line from the chamber to absorb and neutralize the ozone before exhausting to the environment. One pen ray and one grid low-pressure mercury UV lamp (Ultra Violet Products) emitting radiation at 254 nm and the ozone-generating 185 nm were used. The UV intensity at the position of the standard was 20 mW/cm<sup>2</sup> for pen ray lamp and 43 mW/cm<sup>2</sup> for grid lamp [5]. The distance between the standard and the lamps was kept at around 1 cm. The average concentration of ozone was  $80 \pm 5$  ppm, measured by an ozone analyser (Thermo SCIENTIFIC, Model 49i). The exposure time for each section of the surface, if the standard was rotated (for 30 °), was 30 min, altogether 6 hours for full cleaning cycle.

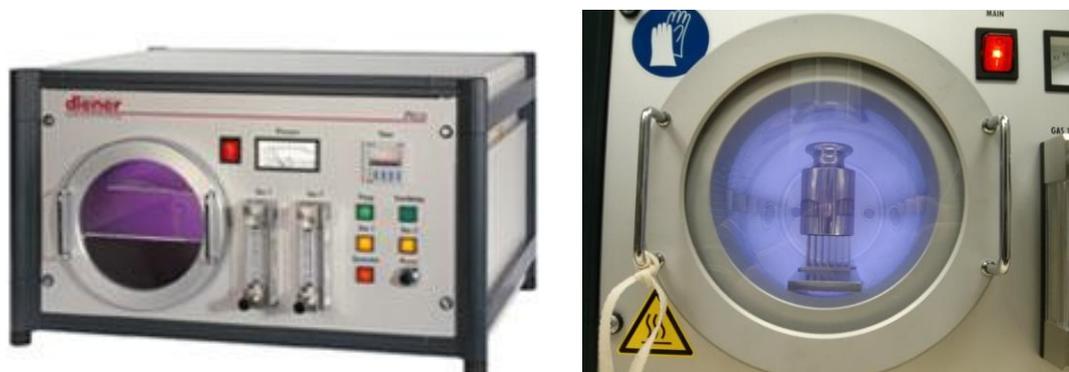
Figure 4: Diener Pico plasma system (left) and cleaning of stainless steel standard with hydrogen plasma (right).

The low pressure plasma cleaning experiments were performed using a commercial Diener Pico plasma system (Figure 4) with 40 kHz, 200 W plasma generator. During the cleaning process the pressure in the 5 L plasma chamber was kept at 0,7 mbar. High-purity hydrogen gas (Messer, 99,999 %) was supplied from a gas cylinder. Applied exposure time for the plasma cleaning cycle was 30 minutes.
